EXECUTIVE SUMMARY

OBSERVATIONS & RECOMMENDATIONS

Horseshoe Pond, Canterbury

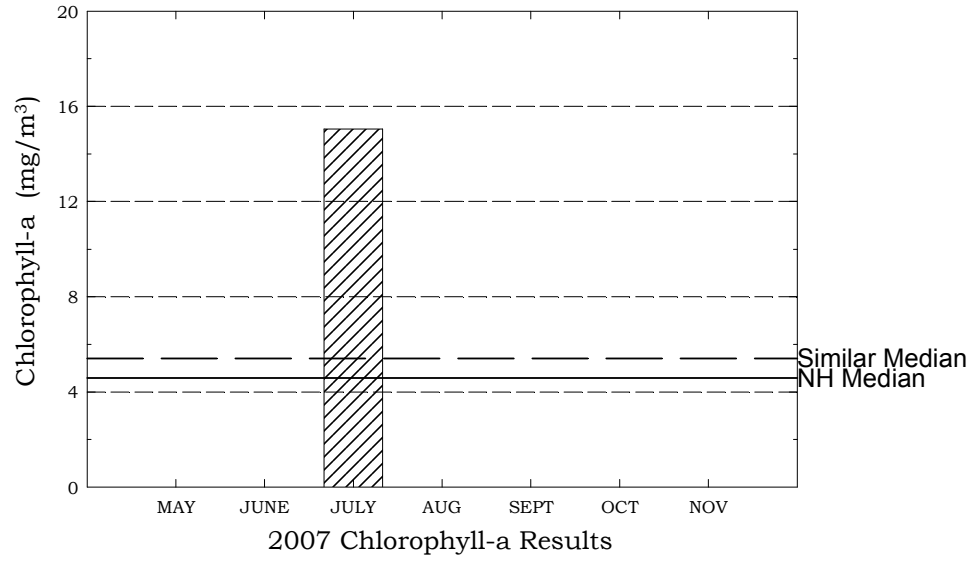
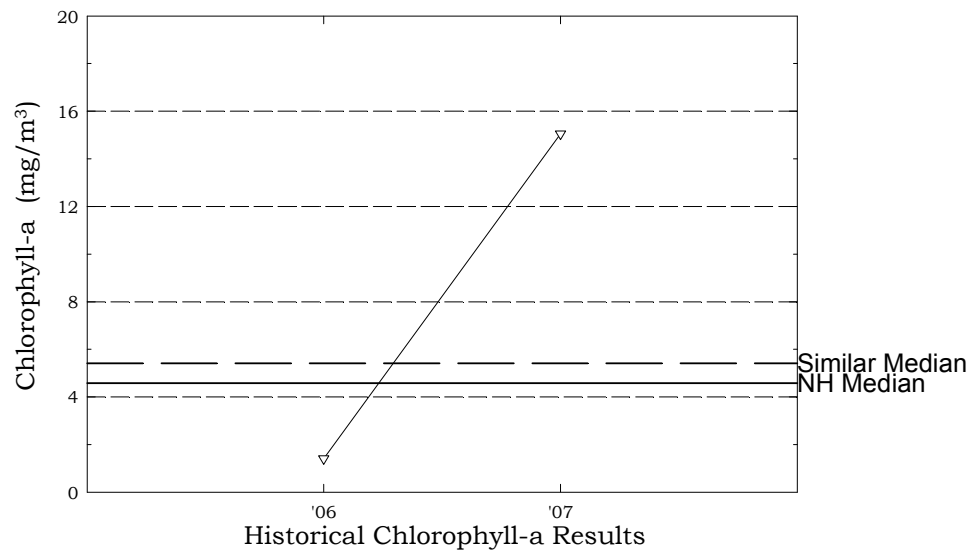
Figure 1. Monthly and Historical Chlorophyll-a Results

Figure 1 depicts the historical and current year chlorophyll-a concentration in the water column.

The current year data (the top graph) show that the chlorophyll-a concentration was **15.04 mg/m³** in **July**. Typically, chlorophyll-a concentration above **15.0 mg/m³** are indicative of an algal bloom. Please observe the pond in late summer and notify the VLAP Coordinator if an algal bloom is occurring.

The historical data (the bottom graph) show that the **2007** chlorophyll-a concentration is ***much greater than*** the state and similar lake medians. For more information on the similar lake median, refer to Appendix D.

Overall, visual inspection of the historical data trend line (the bottom graph) shows an ***increasing*** in-lake chlorophyll-a concentration since monitoring began. Specifically the chlorophyll concentration has ***increased from 2006 to 2007***.

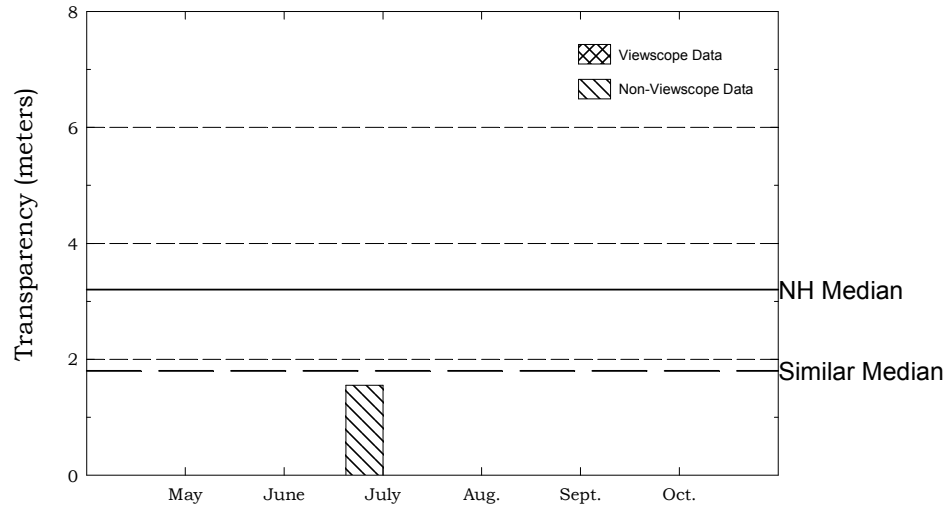
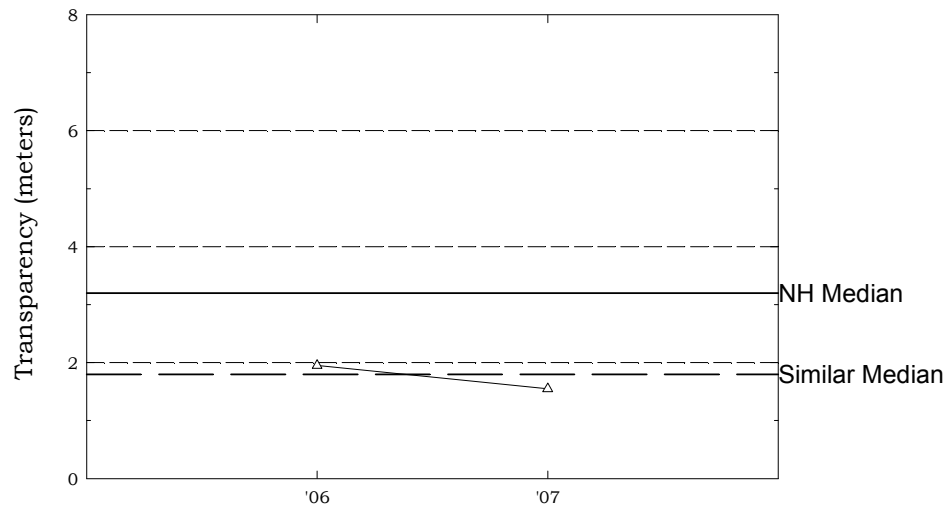
Figure 2. Monthly and Historical Transparency Results

Figure 2 depicts the historical and current year transparency *with and without* the use of a viewscope.

The current year data (the top graph) includes both the non-viewscope and viewscope readings for **2007**.

The current year **non-viewscope** in-lake transparency was **1.55 meters** in **July**.

The historical data (the bottom graph) show that the **2007** mean non-viewscope transparency is ***much less than*** the state median and is ***slightly less than*** the similar lake median. Please refer to Appendix D for more information about the similar lake median.

Visual inspection of the historical data trend line (the bottom graph) shows a ***decreasing*** transparency, meaning that the transparency has ***worsened*** since monitoring began in **2006**.

2007 Transparency Viewscope and Non-Viewscope Results

Historical Transparency Non-Viewscope Results

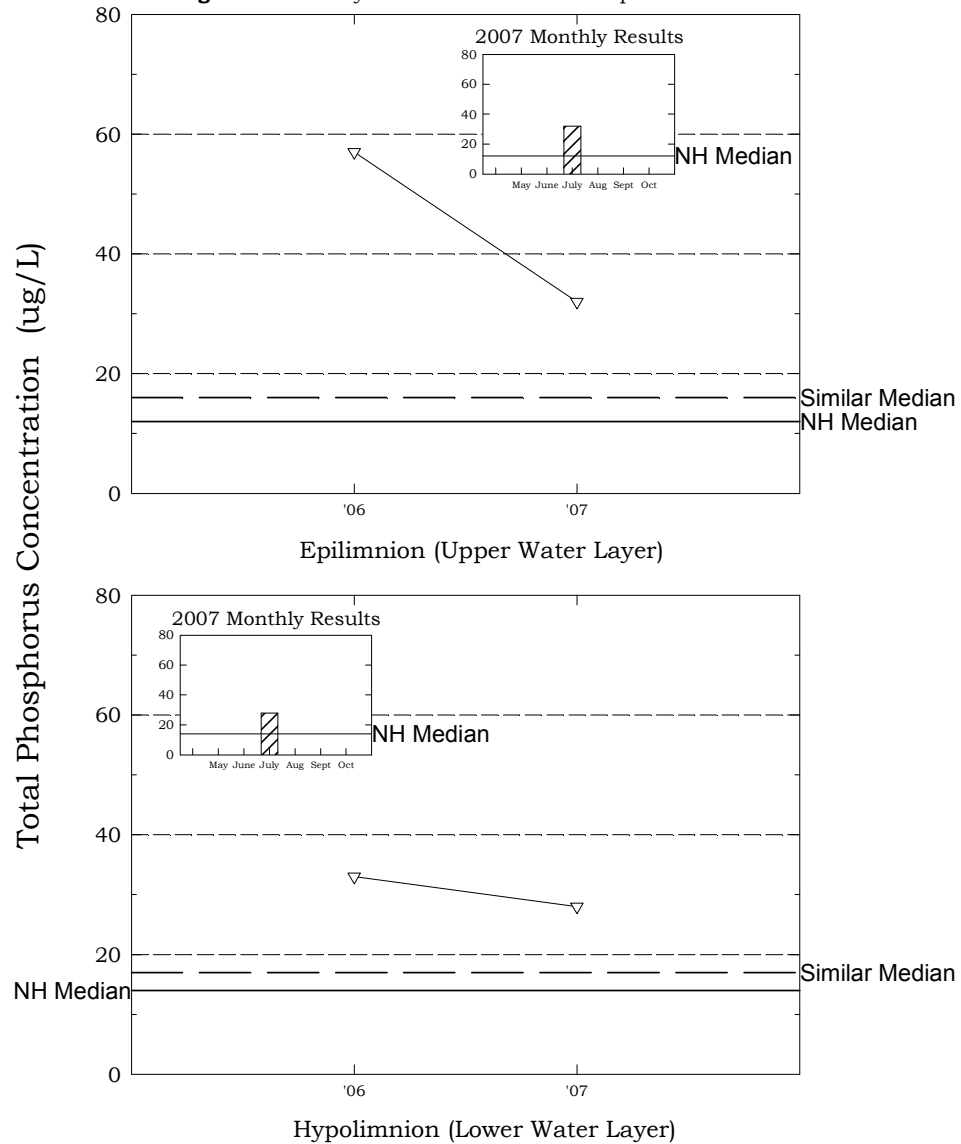
Figure 3. Monthly and Historical Total Phosphorus Data.

The graphs in Figure 3 depict the historical amount of epilimnetic (upper layer) and hypolimnetic (lower layer) total phosphorus concentrations; the inset graphs depict current year total phosphorus data.

The current year data for the epilimnion (the top inset graph) show that the phosphorus concentration was **32 ug/L in July**.

The historical data show that the **2007** mean epilimnetic phosphorus concentration is ***much greater than*** the state and similar lake medians. Refer to Appendix D for more information about the similar lake median.

The current year data for the hypolimnion (the bottom inset graph) show that the phosphorus concentration was **28 ug/L in July**.

The historical data show that the **2007** mean hypolimnetic phosphorus concentration is ***much greater than*** the state and similar lake medians. Please refer to Appendix D for more information about the similar lake median.

Overall, visual inspection of the historical data trend line for the epilimnion and hypolimnion shows a ***decreasing*** phosphorus concentration since monitoring began. Specifically the annual epilimnetic and hypolimnetic phosphorus concentration has ***improved*** since monitoring began in **2006**.

The **elevated** epilimnetic phosphorus concentration measured on the **July** sampling event may have been due to phosphorus-enriched stormwater runoff that flowed into the surface layer of the pond. Weather records indicate that approximately **0.5 inches** of rainfall was measured **24 hours** prior to sampling.
